## **NITIN CORPORATION**

**THE FOLLOWING BARGE MOUNTED POWER PLANT IS AVAILABLE FOR SALE WITH US WITH IMMEDIATE DELIVERY:**

### **TECHNICAL SPECIFICATION OF THE 110 MW BARGE MOUNTED HFO/ GAS GENERATOR BASED POWER PLANT**

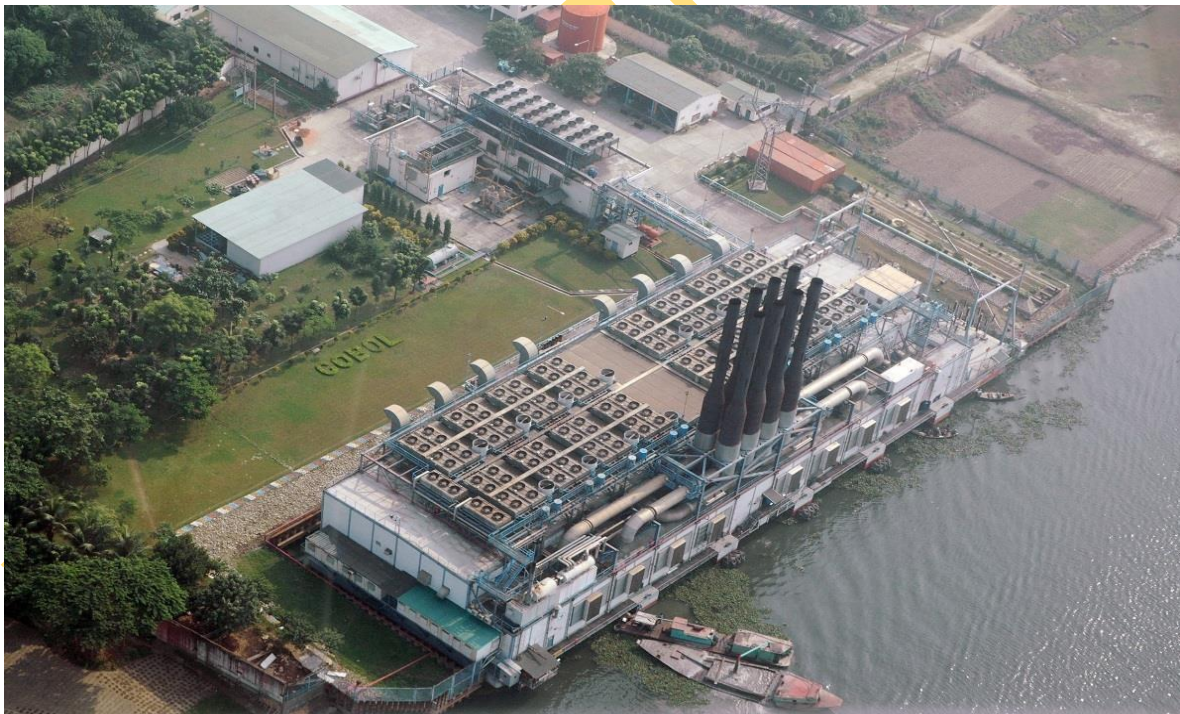
Pic 1: Aerial view of 110 MW power barge.

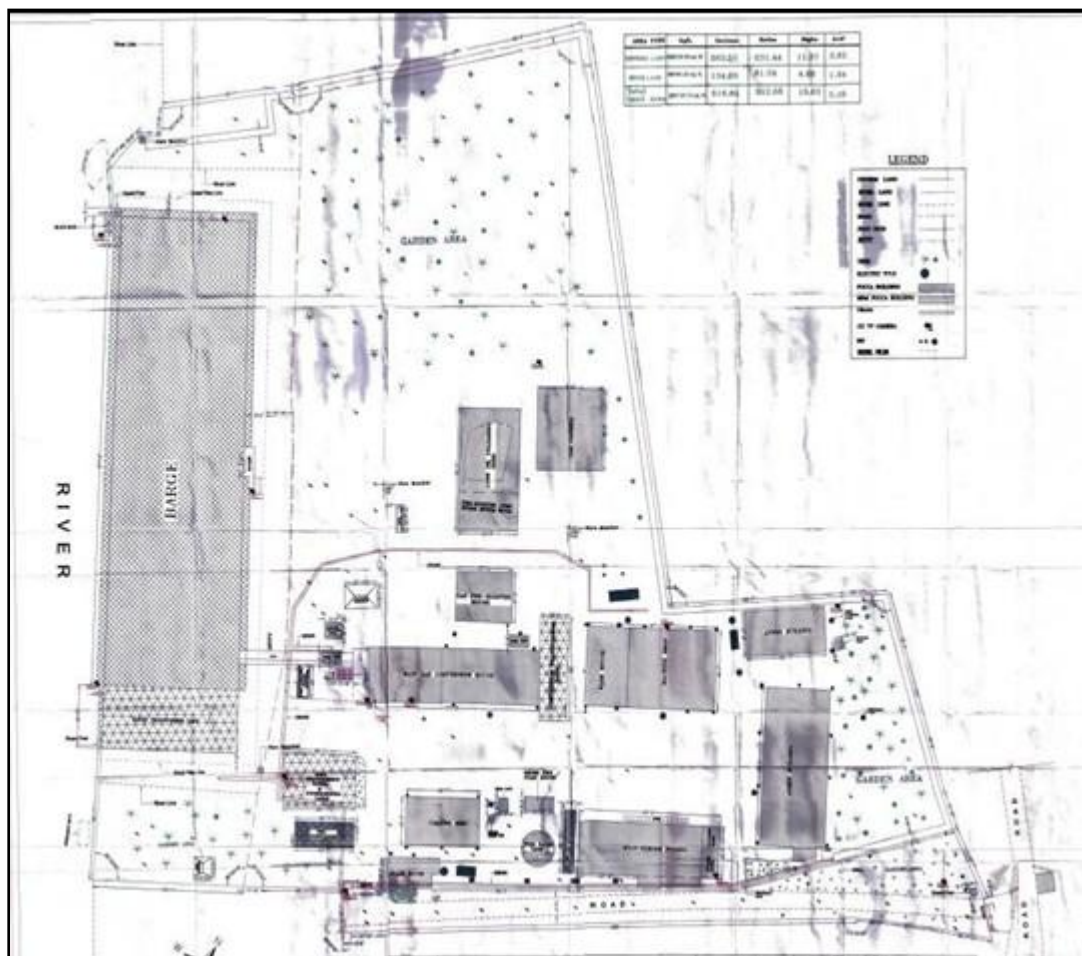
The following provides the layout of the plant:

The layout of barge is conventional with the 2 main step-up transformers and a superstructure in one end containing control room, offices, storage and electrical equipment spaces and a covered machine hall stretching to the other end.

On the main engine hall of the barge, the 8 engine generators are arranged in parallel. Below main engine hall, there are segregated pump room spaces containing fuel and lube oil treatment plants, cooling water system and other ancillary systems together with storage/service tanks for fuel oil/lube oil and other service tanks.

The power plant facility comprises of one floating power barge, gas compressor house / auxiliary equipment, office and storage buildings together with a comprehensive workshop.

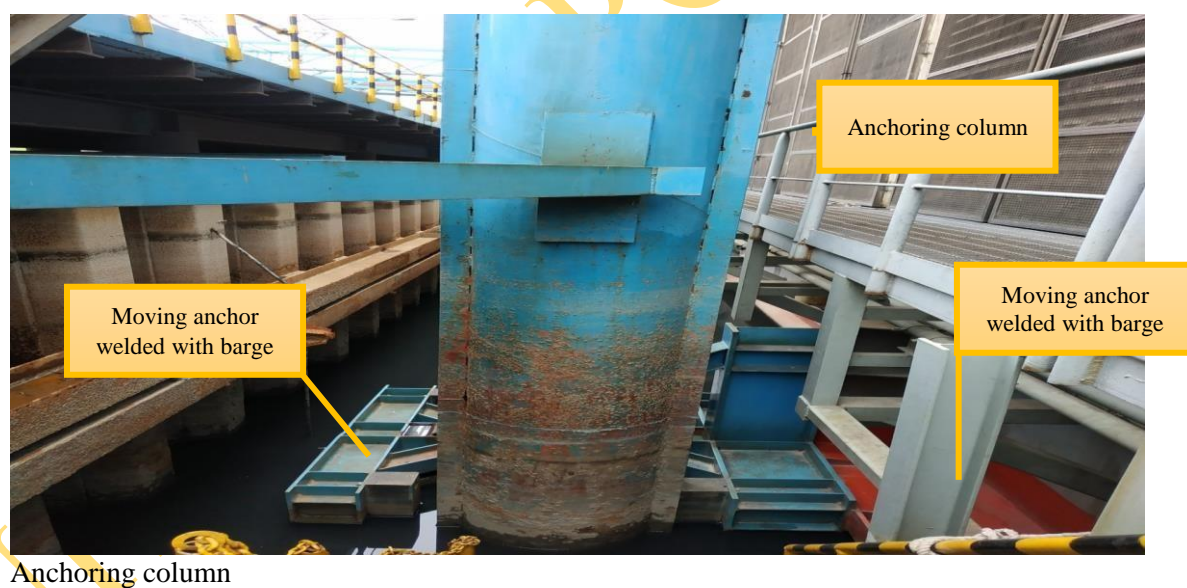
Anchoring mechanism

The power barge is moored to the jetty with seven (7) self-adjusting fender arrangements tied to vertical column directly anchored to the river. This system allows the barges to adjust with the rise and fall in the river water level without any requirement for measures from the staff.

The distance between the bottom of the barge and the sea bottom is minimum 1.5 meters. Normally the river may rise about 3 meters, particularly during the monsoon season. The tide is reported to be about 0.5 meters. Regular dredging is carried out every 3 years by a hired contractor company and the previous dredging of the muddy bottom was done in 2016.
